Report: #215
February 19, 2019
John Smith
Widget Manufacturing
123 Main St.
Chicago, IL.

Michael Fitzpatrick
Thermal Recon
Crestwood, KY. 40014
[Email: mfitz@thermalrecon.com](mailto:mfitz@thermalrecon.com)
Cell: (502)693-7626

Thermal Recon recently conducted an infrared inspection on the electrical distribution system at your facility. The purpose of this inspection was to identify potential problems within that system. Infrared technology is a nondestructive way to identify potential problems within the electrical system.

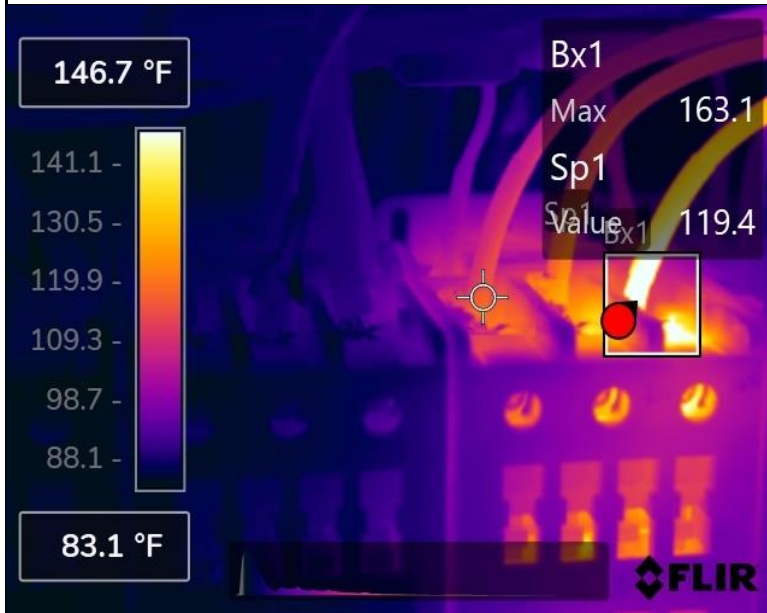
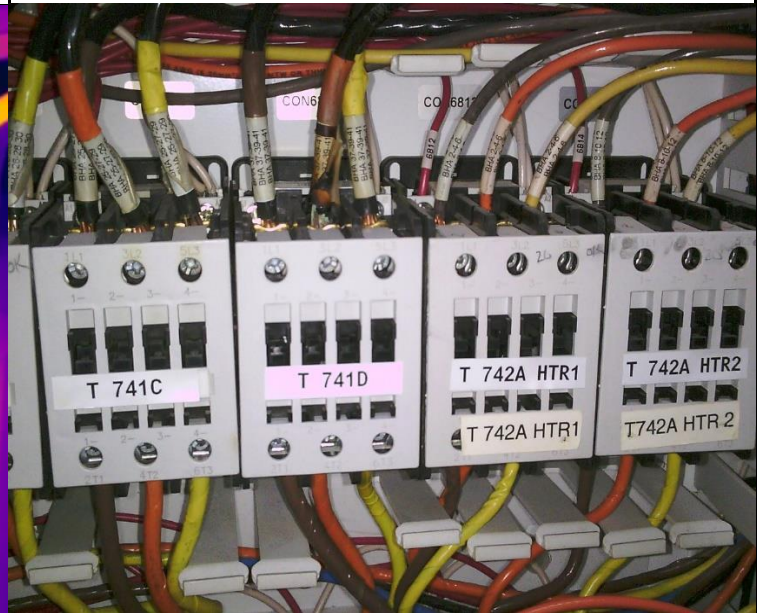
| Widget Manufacturing | Report: #215 | February 19, 2019 | ERROR 1 |

| EQUIPMENT NAME: | RTU 1 - T 742A HTR1 | PRIORITY LEVEL: | 3 |

| TARGET POINT: | C Phase | TARGET TEMP: | 163.1 |
| REFERENCE POINT: | A Phase | REFERENCE TEMP: | 119.4 |
| TARGET AMPS: | 20 | TEMPERATURE DIFFERENTIAL: | 43.7 |

Visual heat damage on B phase line side conductor on component T 741D. Check all connections and repair if necessary.

Check C phase line side lug and conductor on component T 742A HTR1.

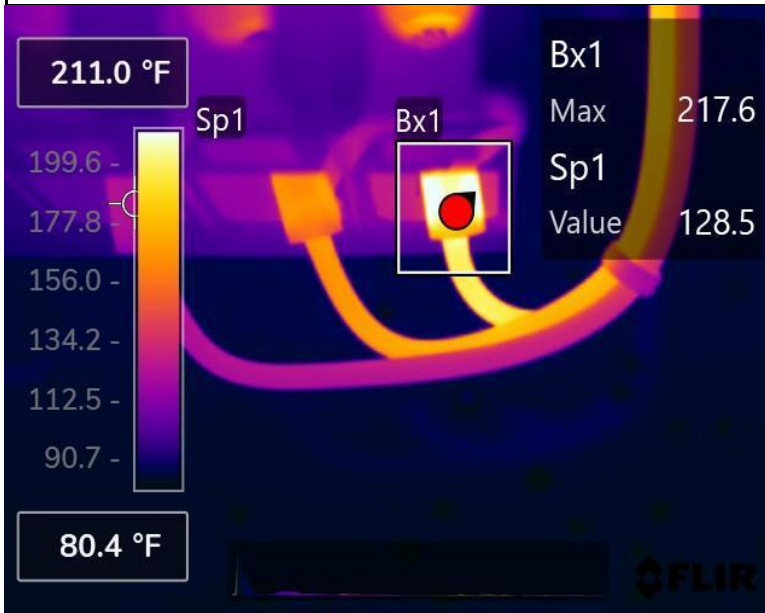
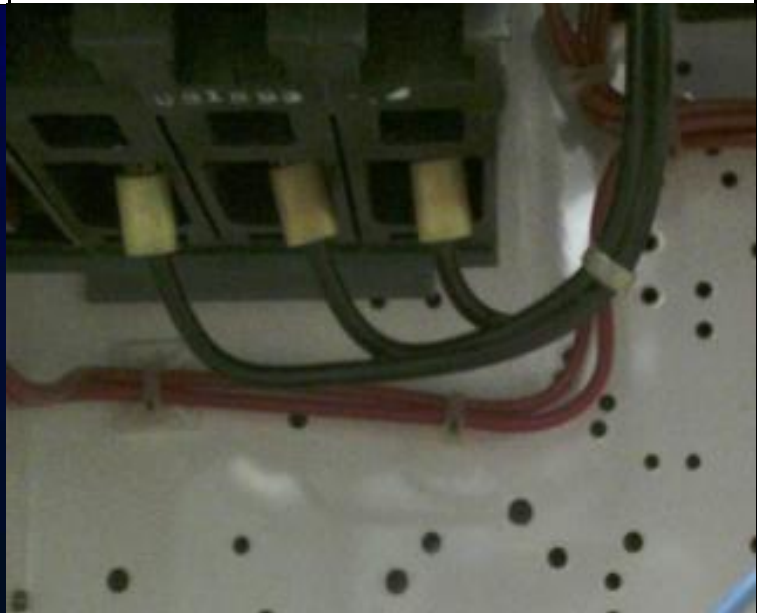
| Widget Manufacturing | Report: #215 | February 19, 2019 | ERROR 2 |

| EQUIPMENT NAME: | Boiler 2 | PRIORITY LEVEL: | 4 |

| TARGET POINT: | C phase load side connection | TARGET TEMP: | 217.6 |
| REFERENCE POINT: | A phase load side connection | REFERENCE TEMP: | 128.5 |
| TARGET AMPS: | 22 | TEMPERATURE DIFFERENTIAL: | 89.1 |

Excessive heat differential between the A and C phase connections.

Check C phase load side connection.

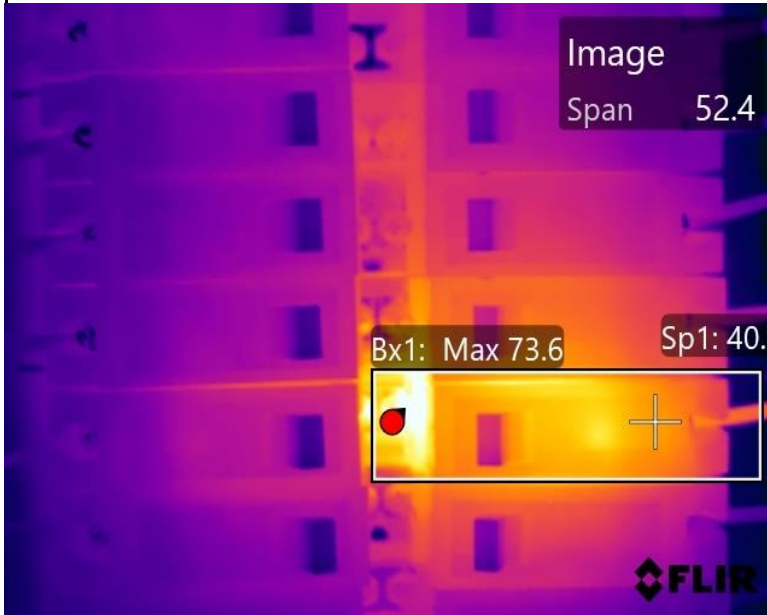
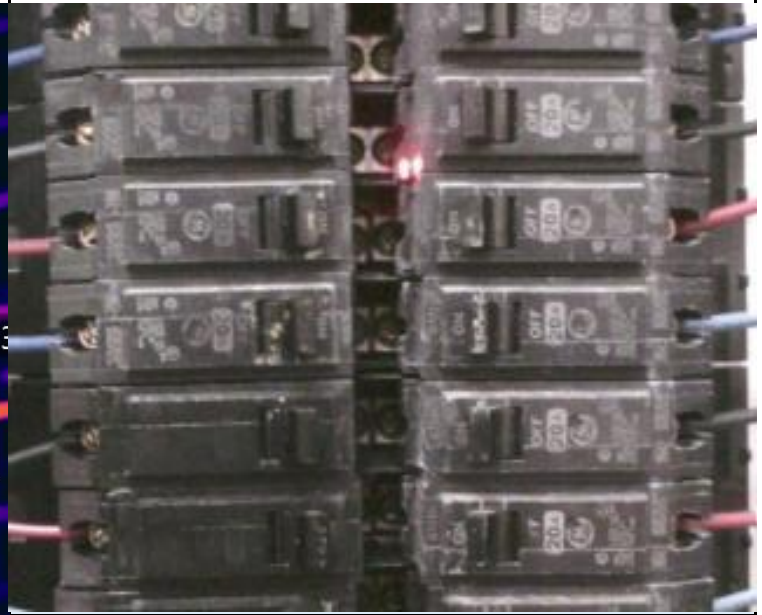
| Widget Manufacturing | Report: #215 | February 19, 2019 | ERROR 3 |

| TARGET POINT: | Breaker 14 buss side | TARGET TEMP: | 73.6 |
| REFERENCE POINT: | Breaker 14 lug side | REFERENCE TEMP: | 40.3 |
| TARGET AMPS: | 13.2 | TEMPERATURE DIFFERENTIAL: | 33.3 |

Possible buss connection problem. Check buss side connection on breaker 14.

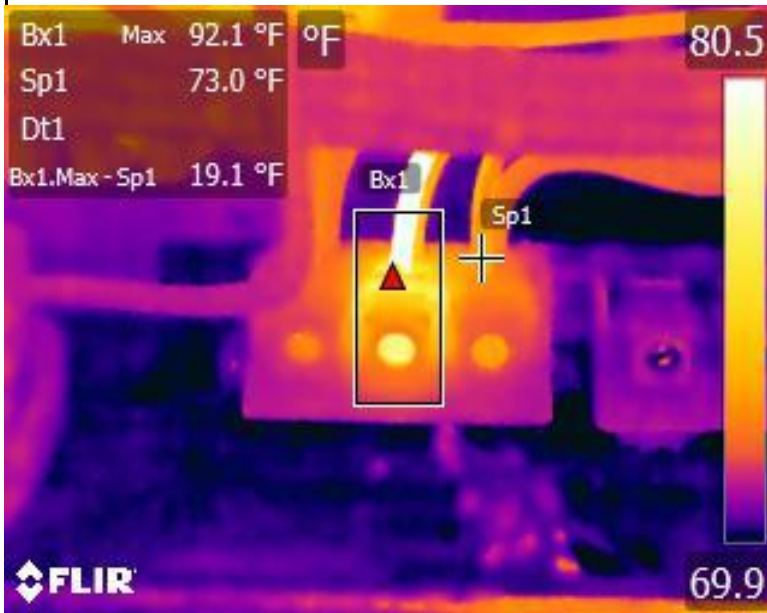
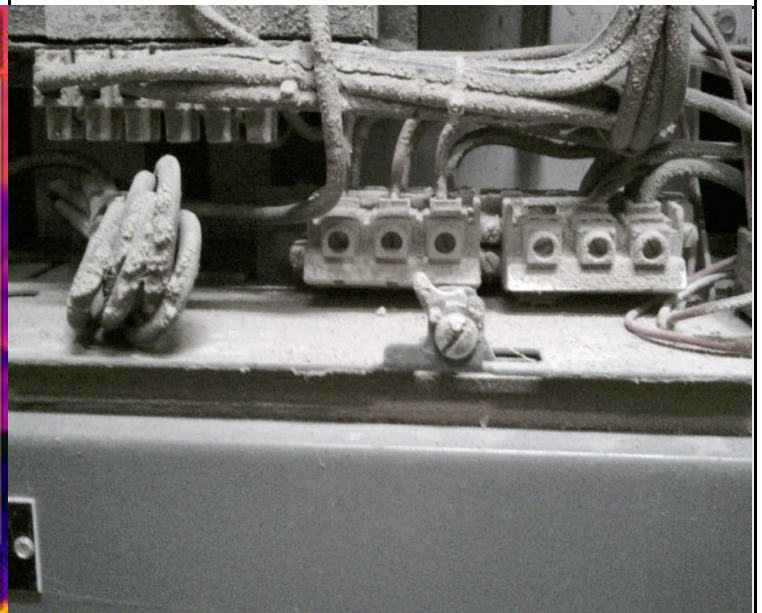
| Widget Manufacturing | Report: #215 | February 19, 2019 | ERROR 4 |

| TARGET POINT: | B phase lug | TARGET TEMP: | 92.1 |
| REFERENCE POINT: | C phase lug | REFERENCE TEMP: | 73 |
| TARGET AMPS: | 3.8 | TEMPERATURE DIFFERENTIAL: | 19.1 |

B phase lug on terminal strip showing a possible problem. Check/repair lug connection.

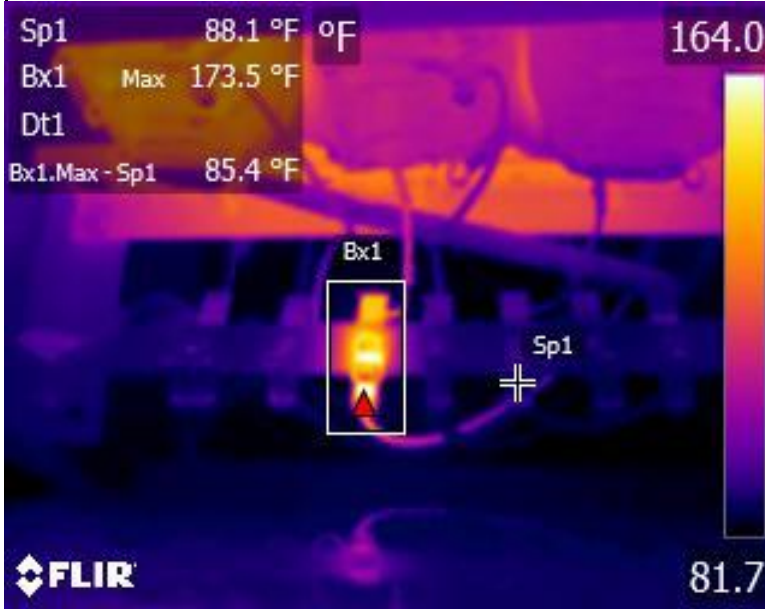
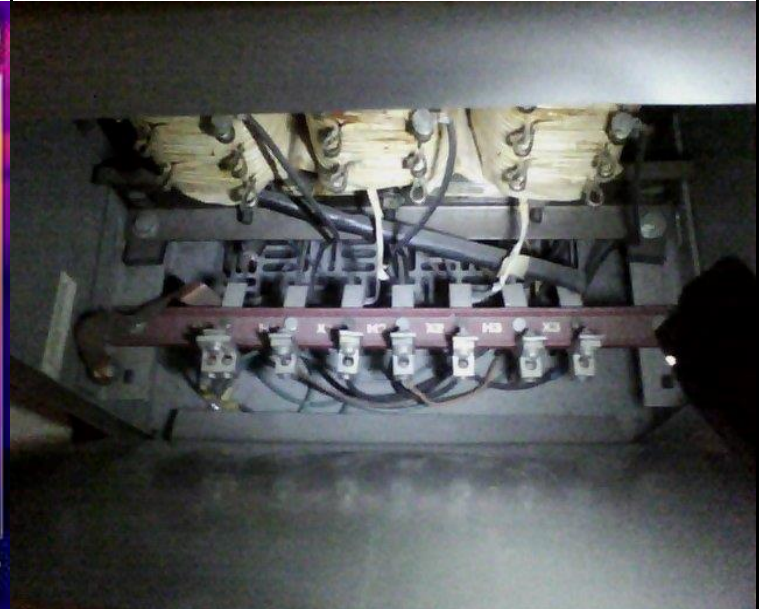
| Widget Manufacturing | Report: #215 | February 19, 2019 | ERROR 5 |

| TARGET POINT: | X1 | TARGET TEMP: | 173.5 |
| REFERENCE POINT: | X2 | REFERENCE TEMP: | 88.1 |
| TARGET AMPS: | NA | TEMPERATURE DIFFERENTIAL: | 85.4 |

Excessive Heat differential between X1 and X2 lug connections. Check/repair X1 lug connection.

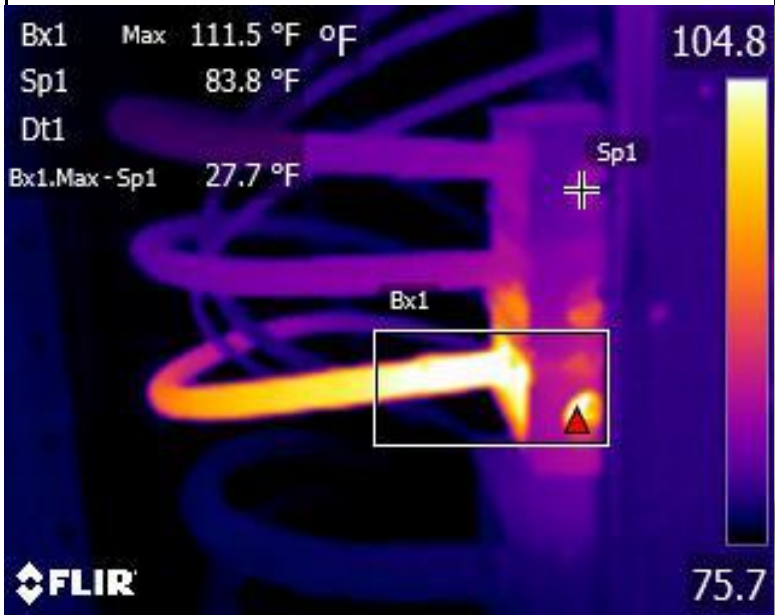
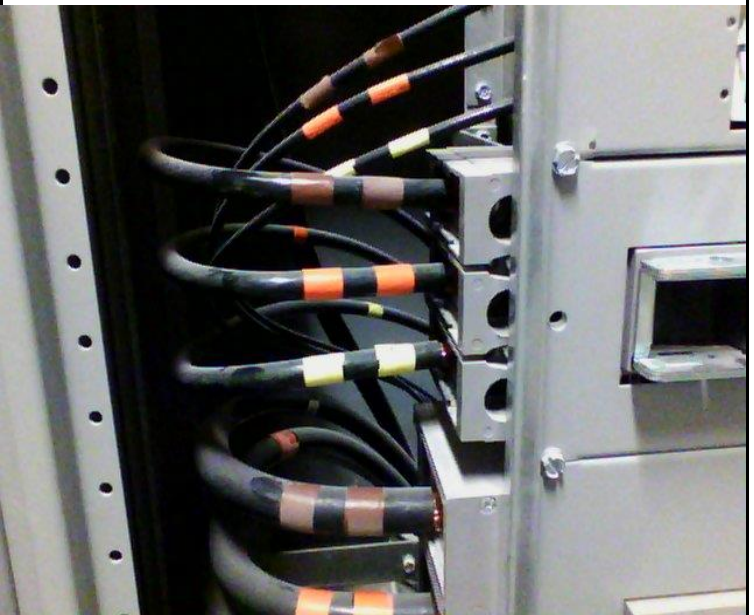
| Widget Manufacturing | Report: #215 | February 19, 2019 | ERROR 6 |

| TARGET POINT: | C phase lug connection | TARGET TEMP: | 111.5 |
| REFERENCE POINT: | A phase lug connection | REFERENCE TEMP: | 83.8 |
| TARGET AMPS: | 71 | TEMPERATURE DIFFERENTIAL: | 27.7 |

Excessive heat on C phase lug to Breaker 5 on distribution panel H6.

Check C phase lug connection.
